# ViberLaser Reference

## Application Demonstration

# Application Scenarios & Testing Results

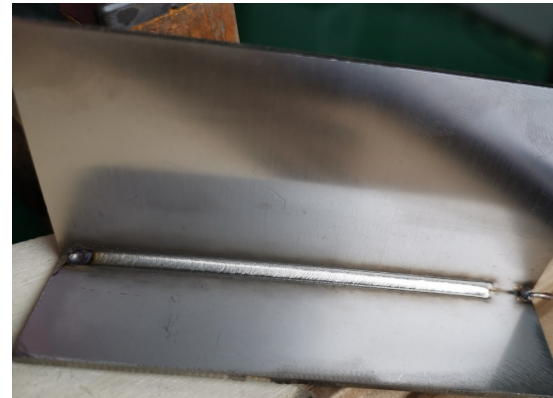
T joint welding test done

**Description:** 1~1.5mm SS sheets are welded together to form a floating roof(cannot get actual product photo), butt joint, and T joint, welding is done in the tank.

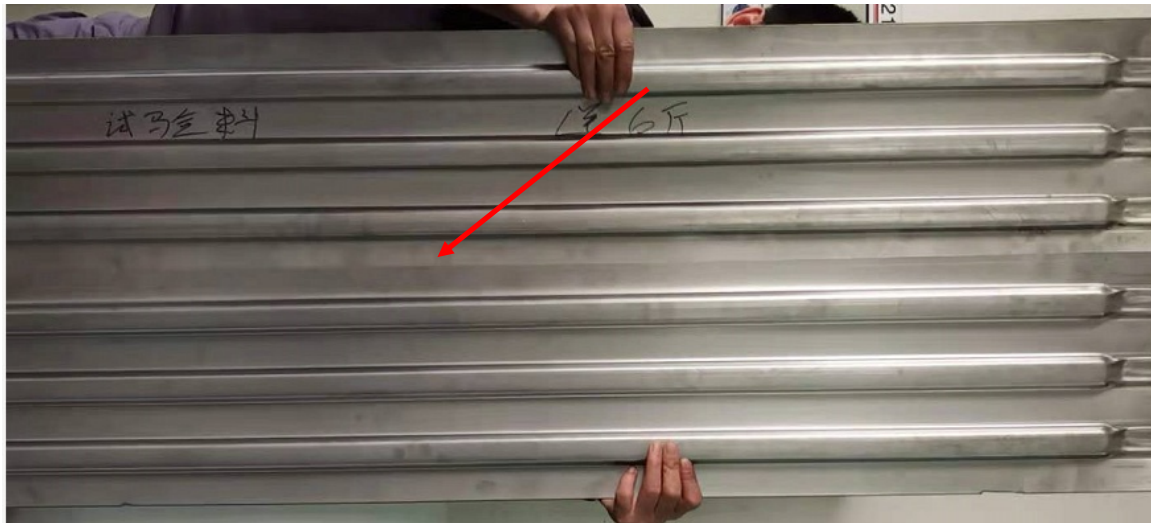
Description: Train roof repair welding, 2mm SS butt joint

Opportunity: Laser welding gets good weld quality, assumed higher stability and durability

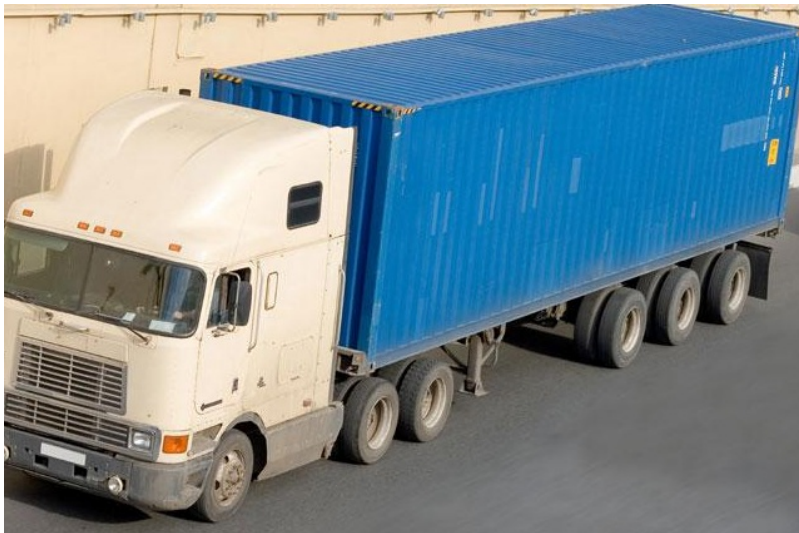
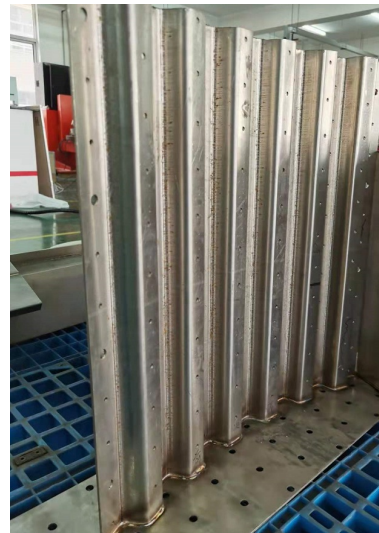
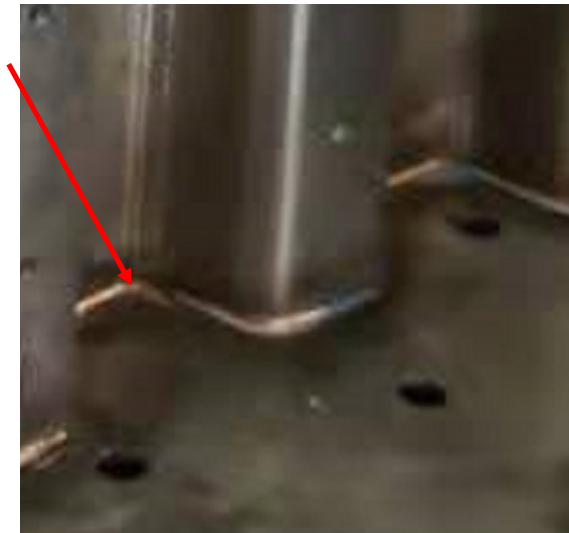
Description: Container corrugated plate, SS corner joint

Opportunity: Laser welding reach higher efficiency, lower distortion

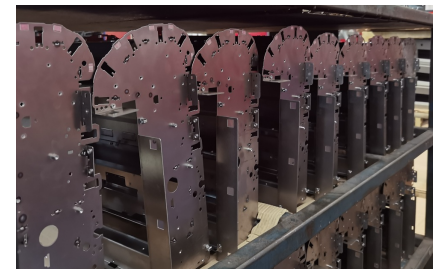
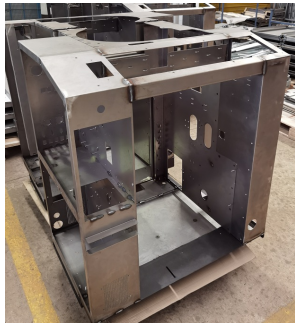
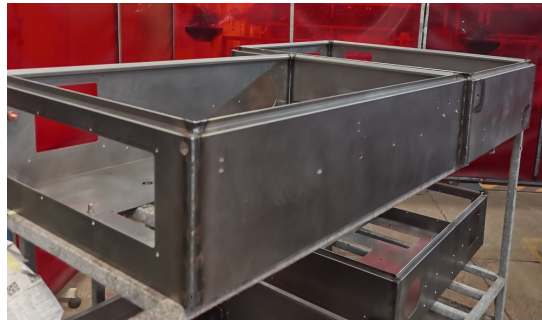
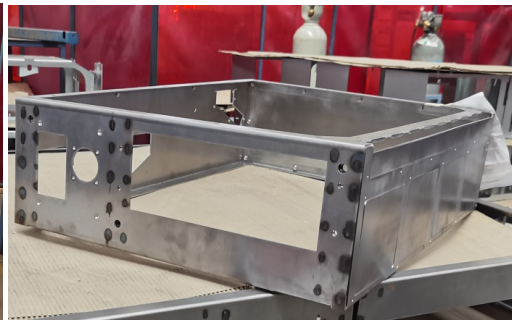
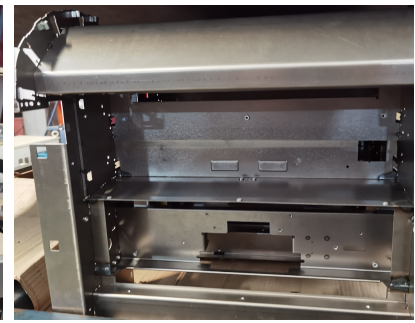
**Description: Cabinet, 1~2mm SS corner joint**

**Opportunity: Laser welding gets good weld quality, lower distortion**

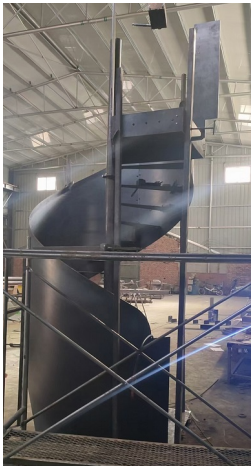
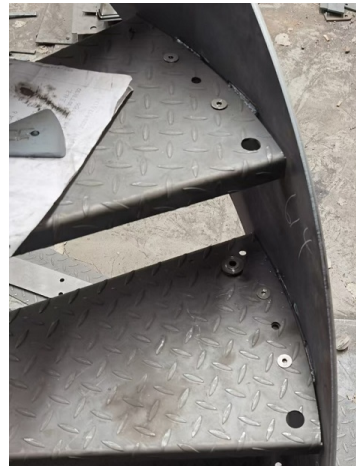
**Description: Yacht step, 2~3mm SS, T joint**

**Opportunity: Laser welding can get good weld quality (manual polishing is not needed) and lower distortion.**

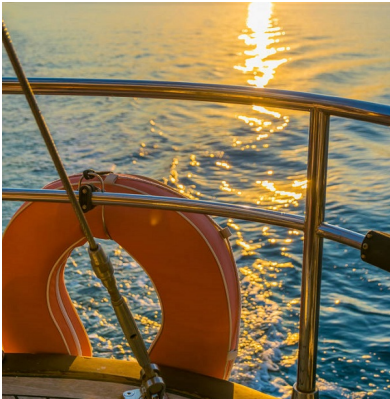
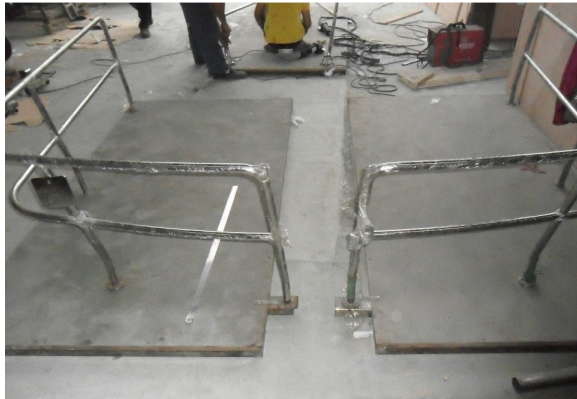
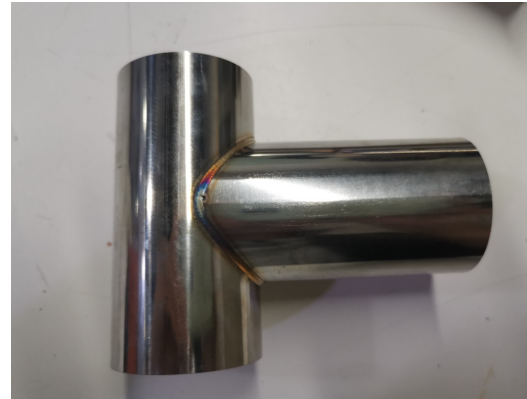
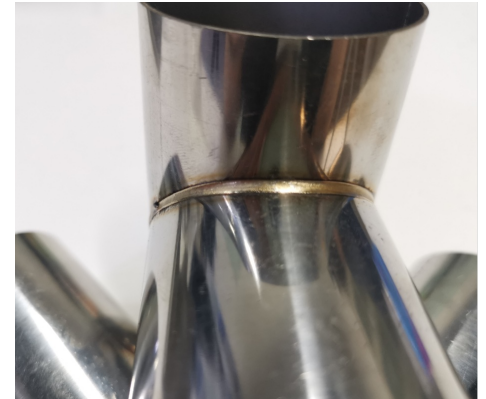
**Description: ~1mm SS, tube to tube intersecting weld**

**Opportunity: Laser welding can get good weld quality (manual polishing is not needed) and low distortion.**

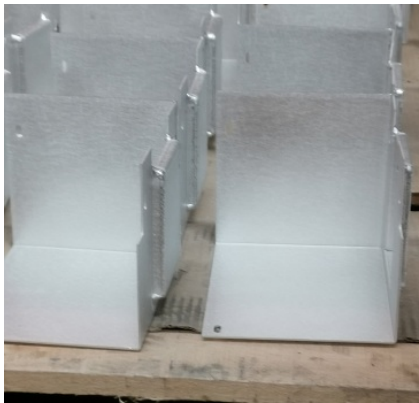
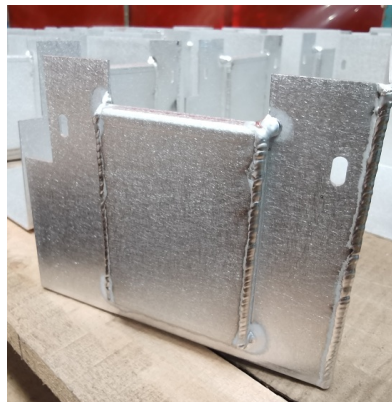
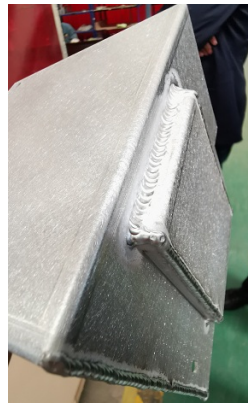
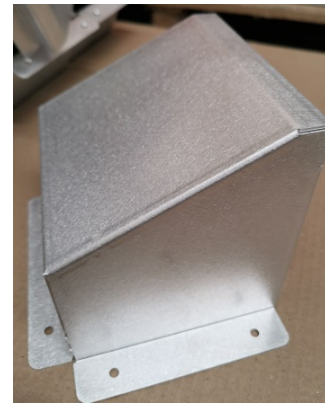
**Description: Cabinet frame**

**Opportunity: Laser welding can get high efficiency and low distortion, having low requirement of welder.**

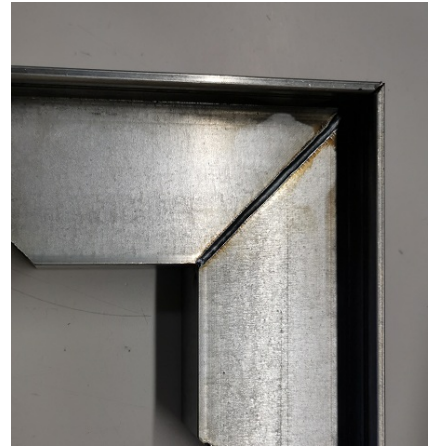
Description: Curtain wall, carbon steel, 1.8mm, butt joint with wire feeding

Opportunity: Laser welding can get high efficiency and have low requirement of welder.  
Small and portable for outdoor operation.
